# 检测报告 Test Report

样品名称	单相四代储能逆变器
Sample Name	Converter Grid-Connect Inverter
型号	X1-HYBRID G4
Type	X1-HYBRID G4
样品接收状态	正常
Sample Receiving State	Normal
样品接收日期	2020.10.15
Sample Received Date	Oct. 15, 2020
样品检测日期	2020.10.15-2020.10.20
Testing Period	Oct. 15, 2020-Oct. 20, 2020

序号 No.	测试项目 Test Item
1	IPX5
2	IP6X

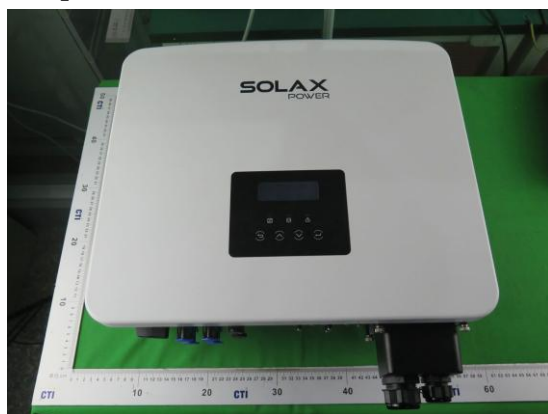
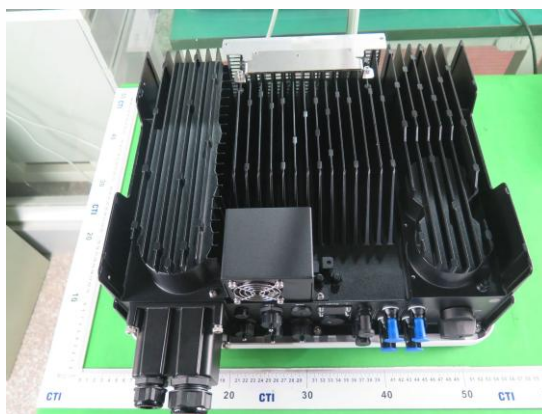
A2200359994101001

#### Sample Photo(s)

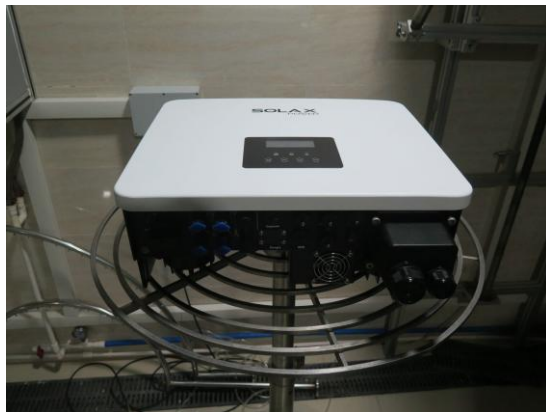
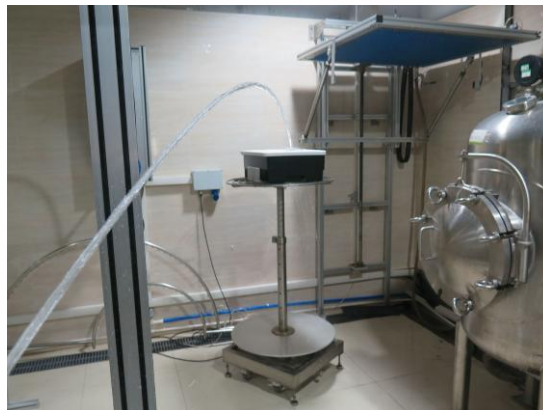
#### Test Photo(s)

样品编号 Sample No.	测试结果 Test Result(s)
A2200359994101001	测试后，目视检查样品内部无进水，IPX5 通过。 After the test, there was no water entered into sample by visual inspect, the sample passed the IPX5 test.

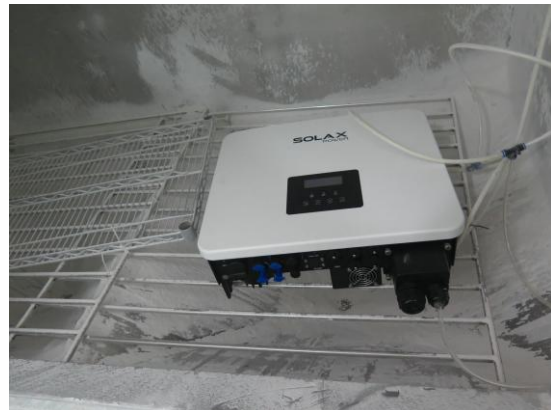
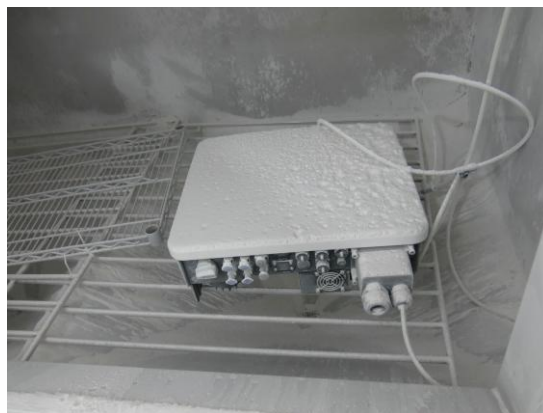
#### Test Photo(s)

样品编号 Sample No.	测试结果 Test Result(s)
A2200359994101001	测试后样品内部未见明显的灰尘沉积，直径 1mm 探针无法进入样品内部金属带电部位，IP6X 测试通过。 No obvious dust was observed in the sample by visual inspection after test. Test probe can't enter the sample. The sample passed the IP6X test.
